A QUARTERLY PUBLICATION  
BOEING.COM/COMMERCIAL/  
AEROMAGAZINE

# AERO

# *Preparing Ramp Operations* for the 787-8

# Engine Fuel Filter Contamination

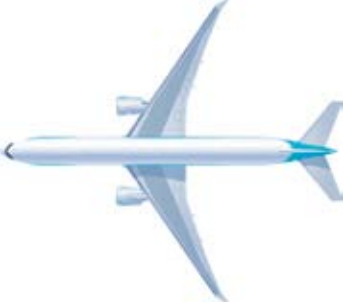
Figure 1

The Boeing 787-8 is similar in size to the 767-300ER. However, the 787-8 has a longer wing span.

AIRPLANE	777-300ER	787-8	767-300ER

LENGTH	242 ft 4 in (73.8 m)	186 ft 1 in (56.7 m)	177 ft 9 in (54.2 m)
WING SPAN	212 ft 7 in (64.8 m)	197 ft 3 in (60.1 m)	156 ft 1 in (47.6 m)
TAIL HEIGHT	61 ft 10 in (18.8 m)	55 ft 6 in (16.9 m)	52 ft 7 in (16.0 m)

To prepare to service the 787 at the ramp, operators need to have basic information about the airplane's dimensions (see fig. 1), servicing locations (see fig. 2), and typical servicing arrangement (see fig. 3).

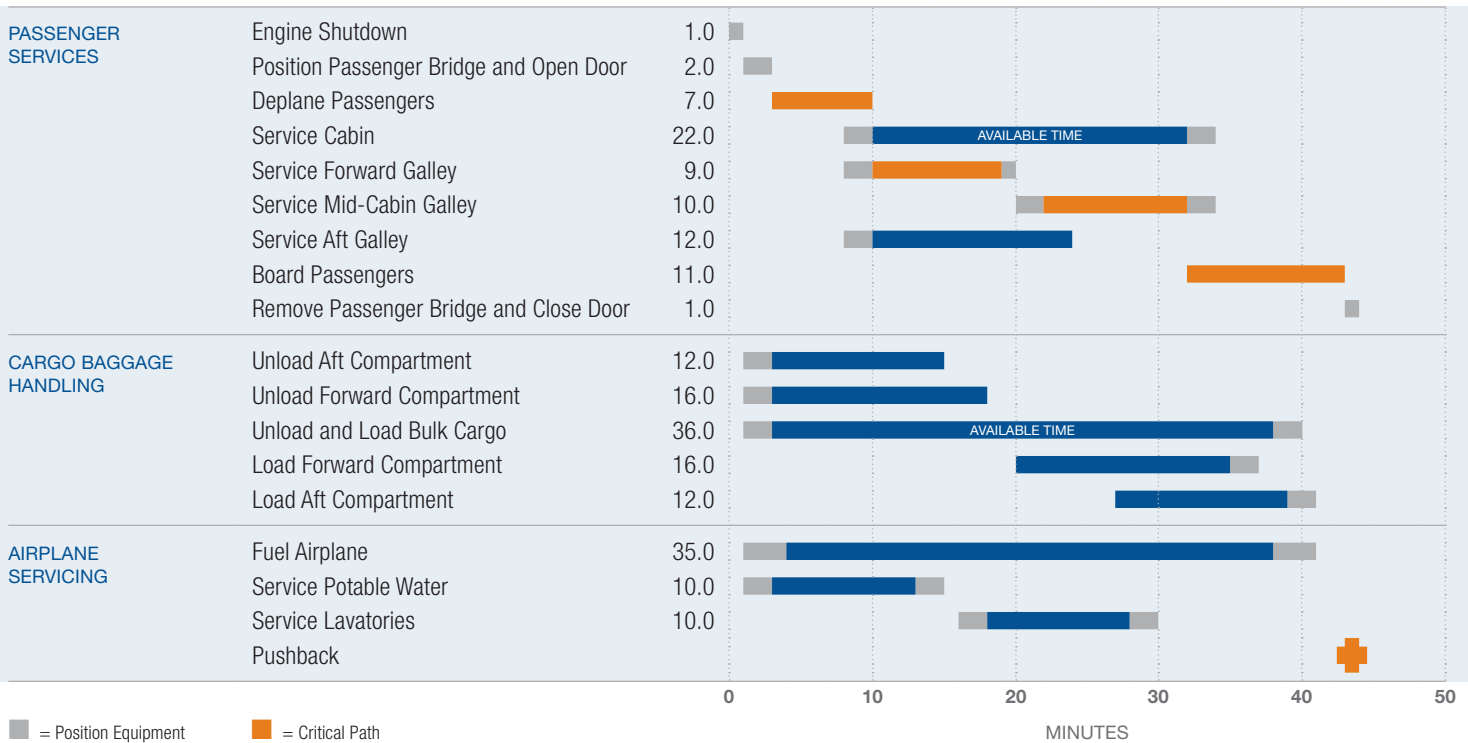
Figure 4

Boeing estimates that a 787-8 airplane with 275 passengers can be turned around at the gate in less than 45 minutes.

PARAMETERS

- 100% passenger and cargo exchange
- 275 passengers, 2 classes, 1 door
- 2 galley service trucks
- 1 lavatory service truck
- Passenger deplane rate is 40 per minute
- Passenger boarding rate is 25 per minute
- Unload and load bulk cargo is available time
- Cabin service is available time
- 12 containers aft
- 16 containers forward
- 29,798 U.S. gallons fuel loaded, 3,730-U.S. gallon (14,120-liter) reserve
- 2 nozzle hydrant fueling at 50 psi
- Bulk cargo in bulk compartment at 75% utilization and 8.5 pounds per cubic foot

Boeing estimates that a 787-8 dual-class airplane with 275 passengers deplaning and boarding through a single door and taking on a full load of fuel can be turned around at the gate in approximately 44 minutes (see fig. 4).

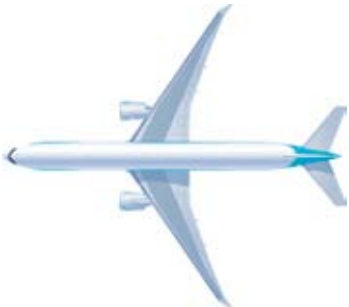
Figure 9

AIRPLANE	777-300ER	787-8	767-300ER

The bulk cargo compartment has a volume of 402 cubic feet (11.38 cubic meters). Standard belt loaders with the capability to reach the cargo door sill height (see fig. 9) can be used on 787-8 airplanes.

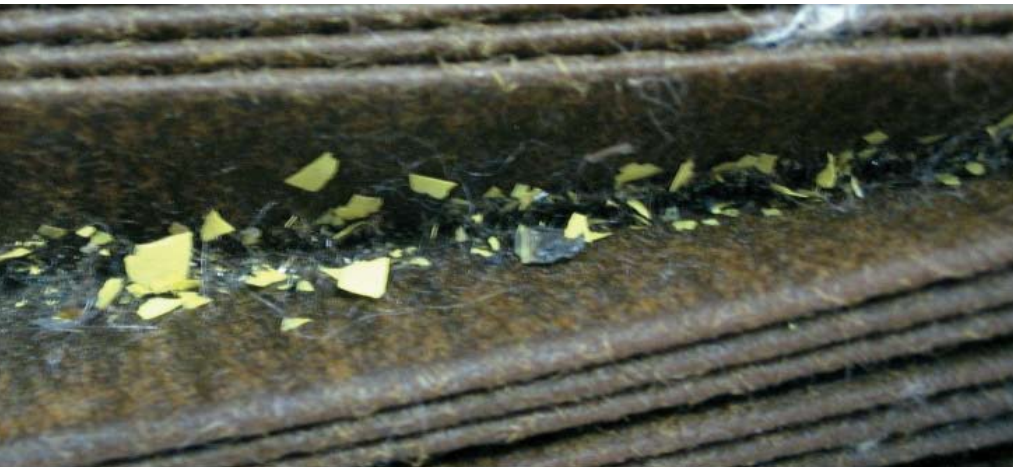
Figure 1

#### CONTAMINATION TRAPPED BY A FUEL FILTER

*A visual inspection of a fuel filter reveals a variety of contaminants.*

problem. The majority of the fuel filters examined were filled with silicates (i.e., dirt), sulfates, iron oxide (i.e., rust), and salts (see fig.1). The team could not draw a specific conclusion but suspected that the contamination was being uplifted with the fuel. The team also suspected that the fuel technically would pass the ATA 103 fuel handling specification for cleanliness.

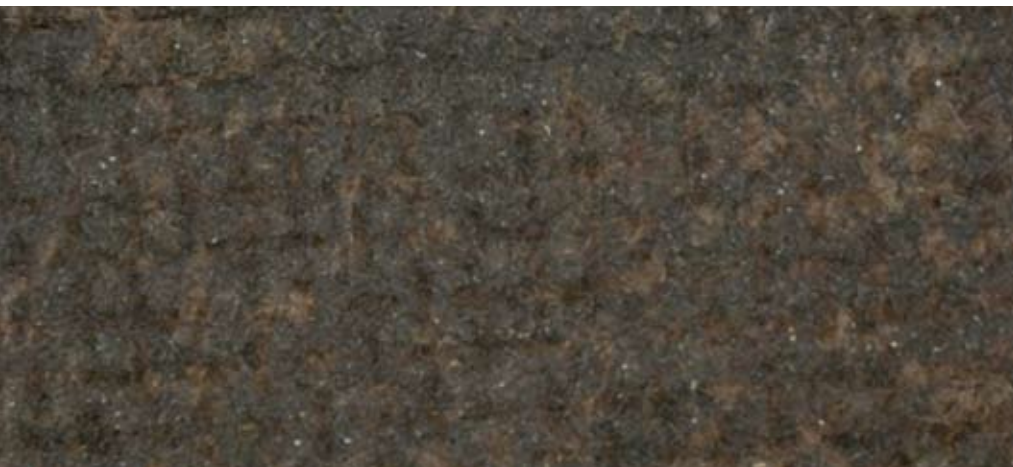
Figure 2

#### CONTAMINATED FUEL FILTER CAUSES LOSS OF POROSITY

**The individual particulates found on fuel filters are very small, often less than 1 micron in size. However, these particulates become bound together on the filter medium and filter screen.**

**Category 1: Foreign Objects.** This category is for any material found on the filter from a maintenance activity or degradation of the airplane or ground fuel system. Foreign objects include paint chips, paper, aluminum chips, sealant chips, composite materials, and O-rings and gasket materials (see figs. 2 and 3).

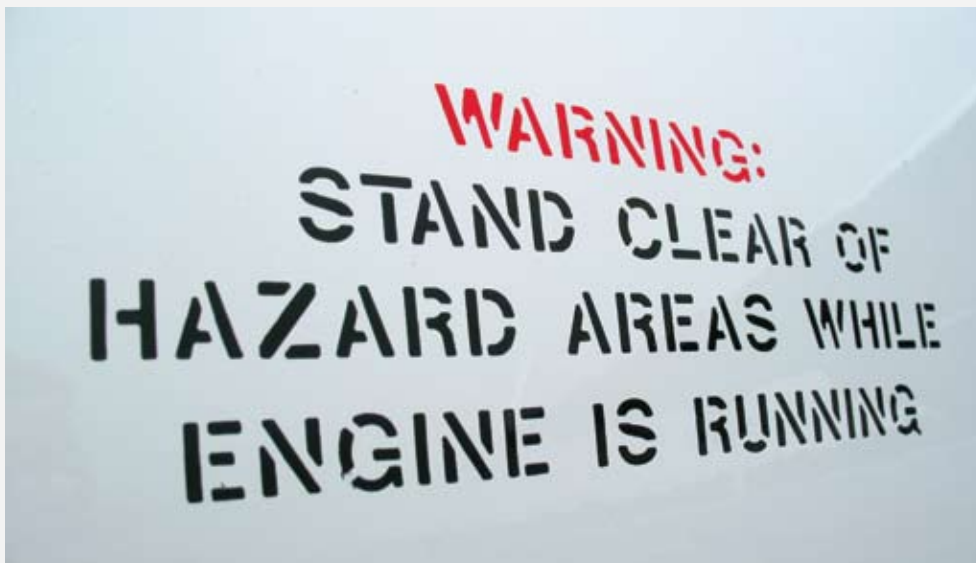
Figure 3

#### HAZARD-AREA WARNING DECALS

*These hazard-area warning decals are located on both left and right engine nacelles. For the 737, hazard-area warning stripes and decals have been applied to all CFM56 engine nacelles prior to delivery. Inlet hazard-area warning stripes and decals were applied to all JT8D engine nacelles prior to delivery beginning with airplanes delivered in May 1984. Boeing Service Bulletin 737-11-1010, Revision 1, dated June 21, 1985, provides for retrofit application of warning stripes and decals on JT8D engine nacelles delivered prior to this date.*

All 737-300/-400/-500 and Next-Generation 737 airplanes at delivery have Boeing-applied hazard-area red warning stripes, above-idle hazard-area decals, and “no-entry” decals applied to the engine nacelles (see fig. 3). Similar hazard-area warning stripes and decals were also applied to all 737-100/-200 airplanes beginning with Line Position 1020, which was delivered in May 1984. For 737-100/-200 airplanes prior to Line Position 1020, hazard-area warning stripes and decals can be applied per Boeing Service Bulletin 737-11-1010 Revision 1, dated June 21, 1985.

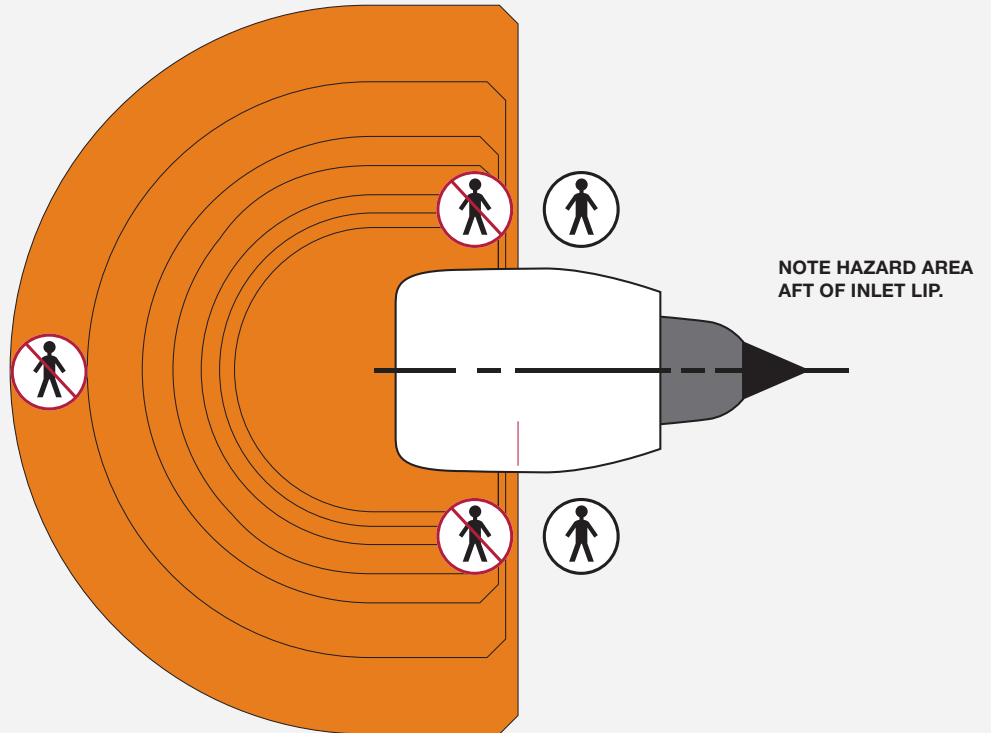
Figure 5

## INLET INGESTION WARNING POSTER

INLET SUCTION FORCES ARE HARDLY NOTICEABLE BEYOND THE INLET HAZARD AREA BUT INCREASE DRAMATICALLY WITH EACH STEP INTO THE HAZARD AREA.

BE AWARE OF ENGINE INLET HAZARD AREA. ONE MISSTEP INTO THESE AREAS AND IT MAY BE YOUR LAST.

in the vicinity of an operating jet engine. Inlet ingestion warning posters are available from Boeing Field Service representatives (see fig. 5). For 737 operators, a videotape presentation regarding inlet ingestion warning, "737 CFM56 Engine Maintenance Safety" (catalog number VIDN931117), may be purchased through the Boeing subsidiary Alteon at [www.alteontraining.com](http://www.alteontraining.com) or [info@alteontraining.com](mailto:info@alteontraining.com).
